Corrosion Report

Equipment Location ID 0955-023-004
Equip. Location Descrip. AQUA AMMONIA

For Location ID: 0955-023-004 in Unit: 0955

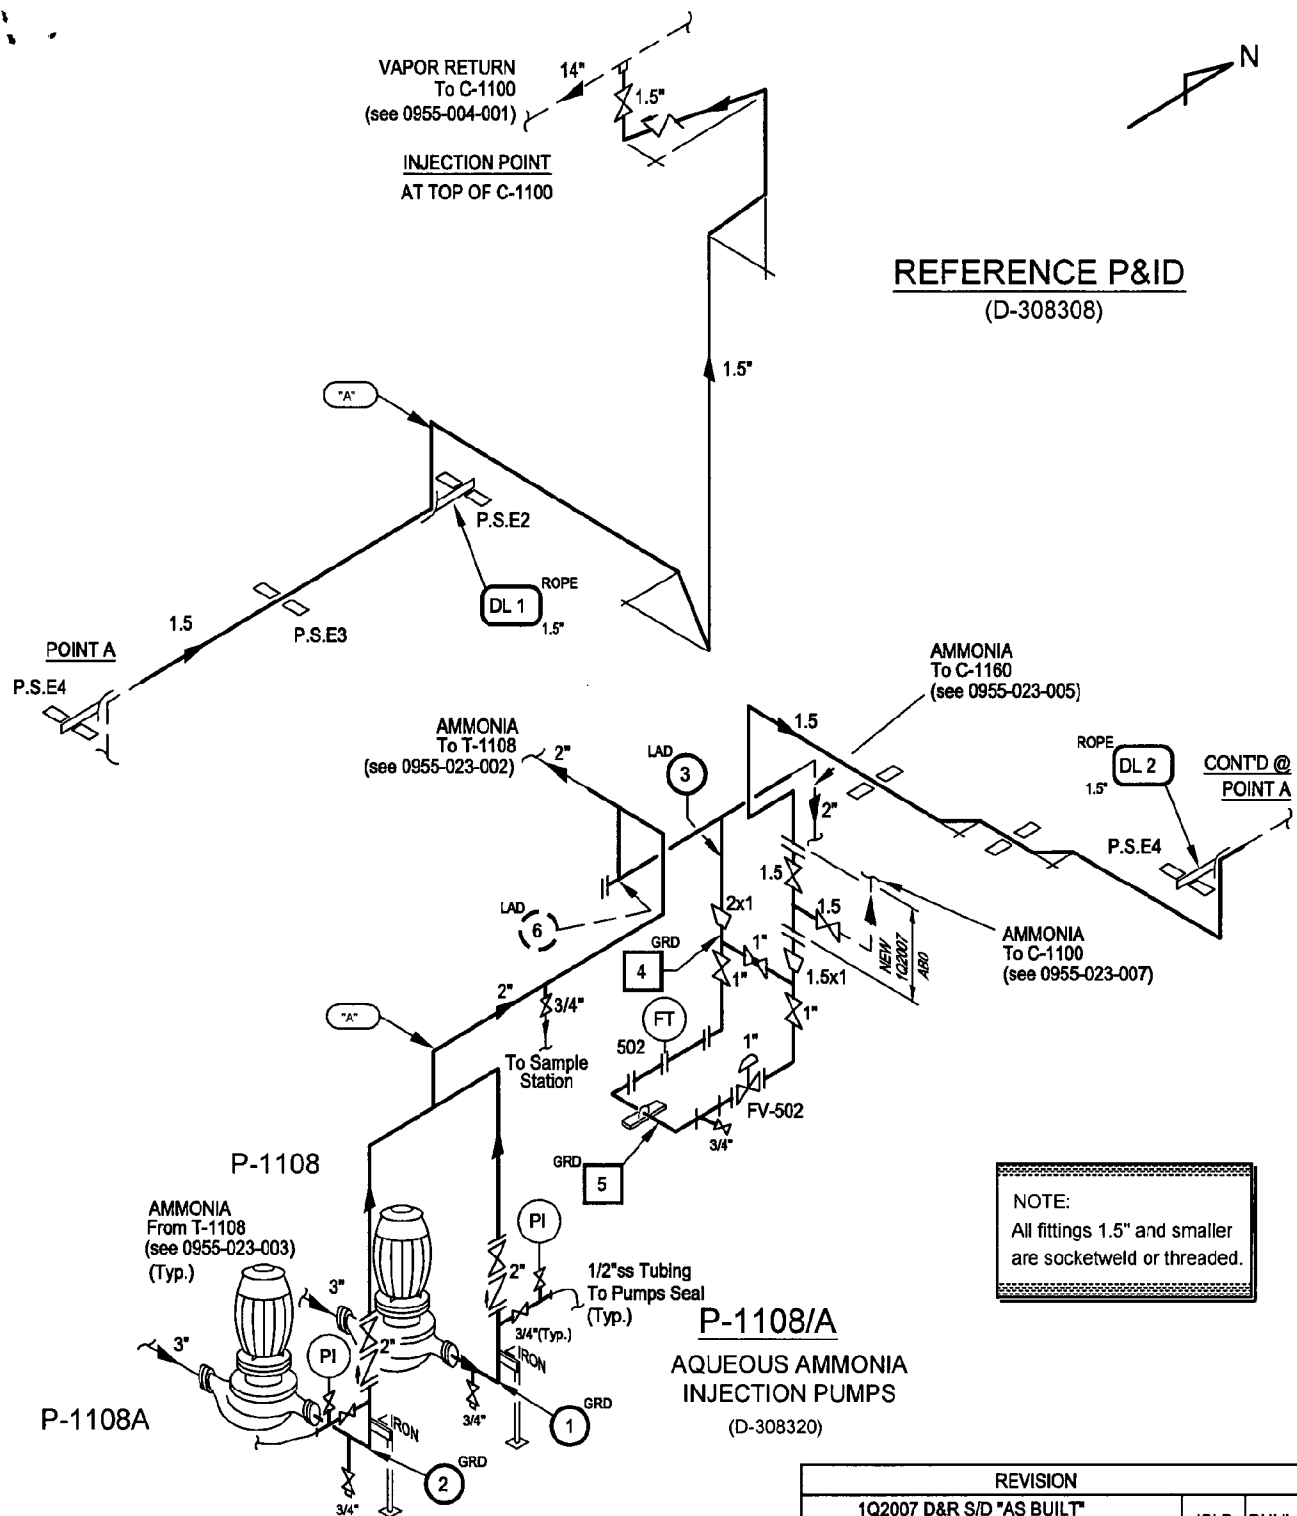
DP ID	MEAS METH	DP STAT	DP SZ	DT TYPE	BASE	MEAS 5	MEAS 4	MEAS 3	NEAR	LAST	MIN VALUE	CCR	REM LIFE
001.1	UT	A	2.00	ELL	0.170 09/02					0.160 03/10	0.100	1.33	45.15
001.2	UT	A	2.00	ELL	0.160 09/02					0.160 03/10	0.100	0.00	∞
002.1	UT	A	2.00	ELL	0.260 09/02					0.240 03/10	0.100	2.66	52.69
002.2	UT	A	2.00	ELL	0.220 09/02					0.230 03/10	0.100	0.00	∞
003.E	UT	A	2.00	PIPE	0.150 08/00					0.140 03/05	0.100	2.15	18.63
003.N	UT	A	2.00	PIPE	0.150 08/00					0.160 03/05	0.100	0.00	∞
003.S	UT	A	2.00	PIPE	0.150 08/00					0.160 03/05	0.100	0.00	∞
003.W	UT	A	2.00	PIPE	0.150 08/00					0.150 03/05	0.100	0.00	∞
004.R	RT	A	1.00	PIPE	0.150 08/00					0.150 05/05	0.100	0.00	∞
005.R	RT	A	1.00	PIPE	0.170 08/00					0.270 05/05	0.100	0.00	∞
